Owner Builder Inspection Report

**PREPARED FOR USE IN ASSESSING A PROPOSAL FOR WARRANTY INSURANCE
TO BE ISSUED UNDER SECTION 137B (2)(a) OF THE BUILDING ACT 1993**

Brick veneer, two storey dwelling with attached double garage

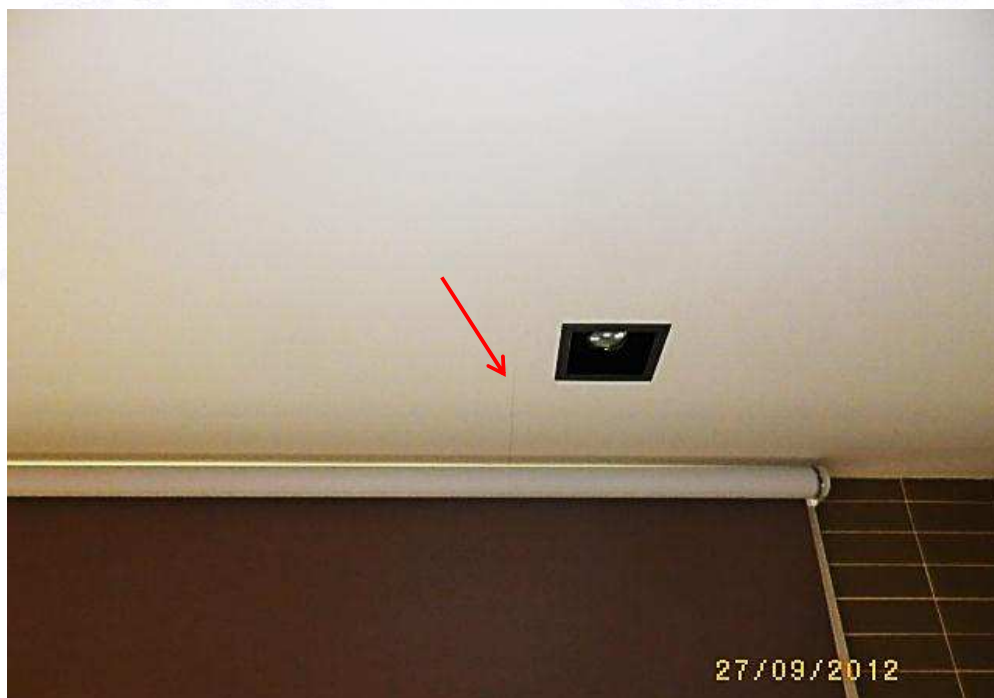
- 1) Crack in the plaster of the family room ceiling

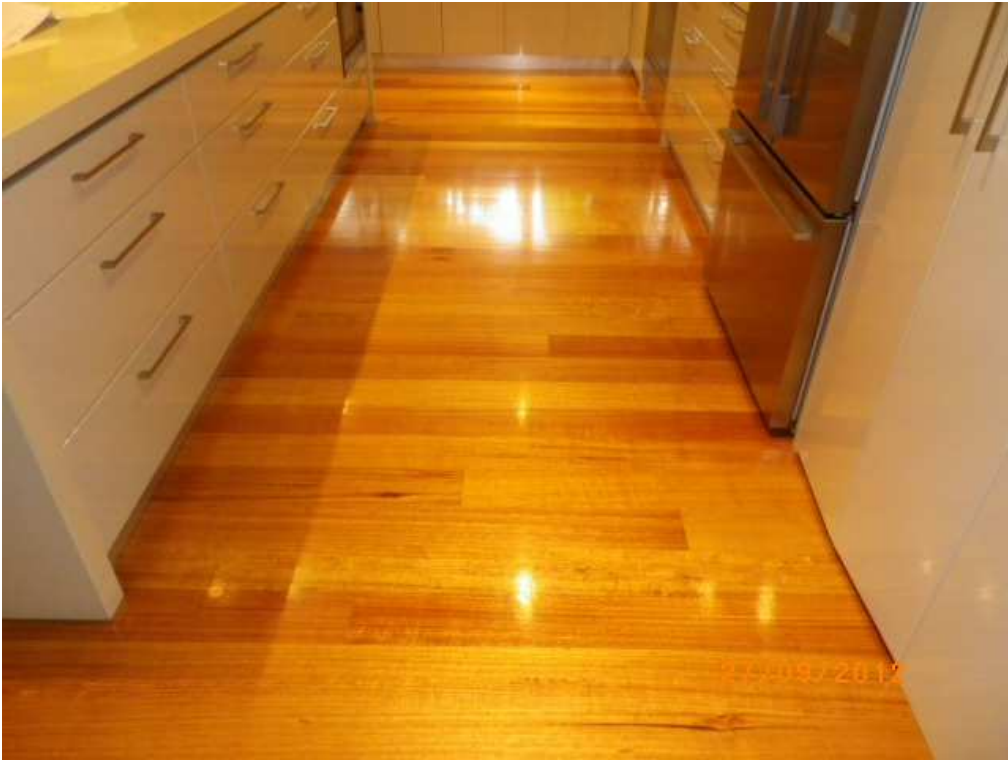
- 2) Small dents in the timber flooring in areas (most likely from high heel shoes)

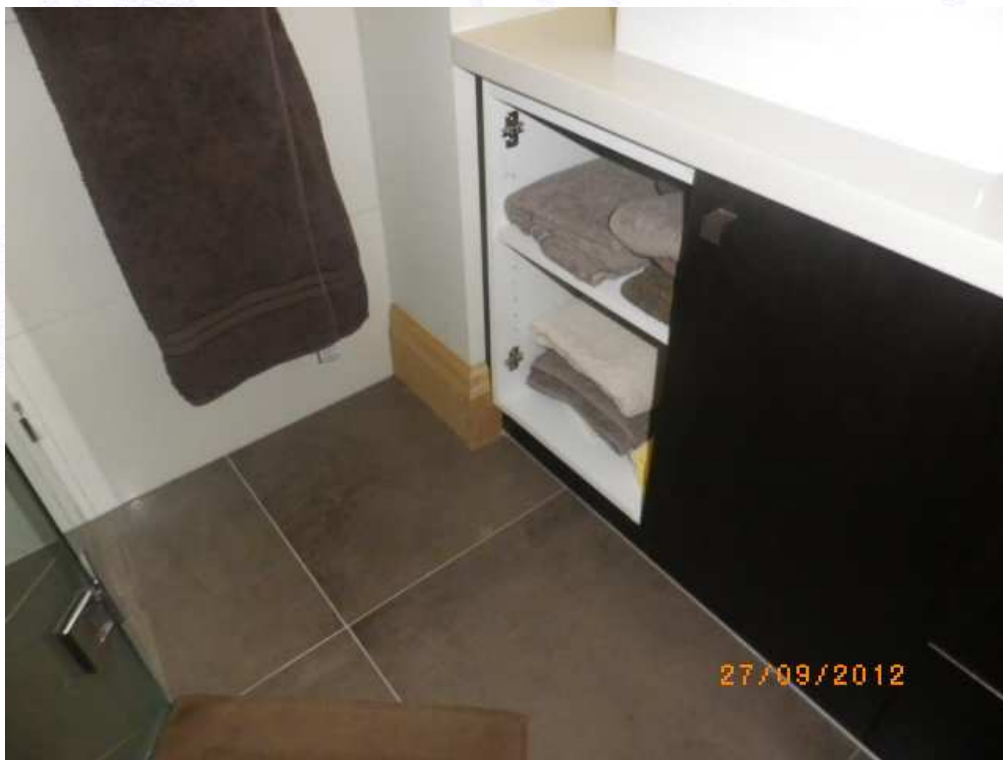
- 3) Unfinished repair to the skirting board and vanity door in the upstairs bathroom

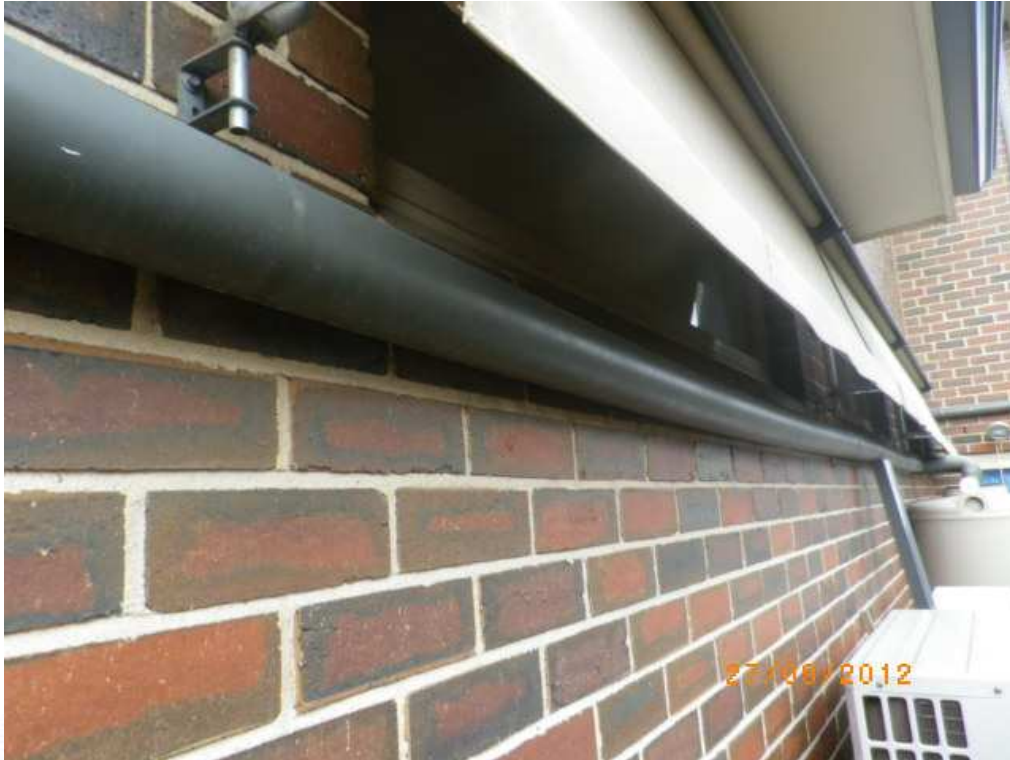
- 4) The storm water piping to the water storage tanks are sagging

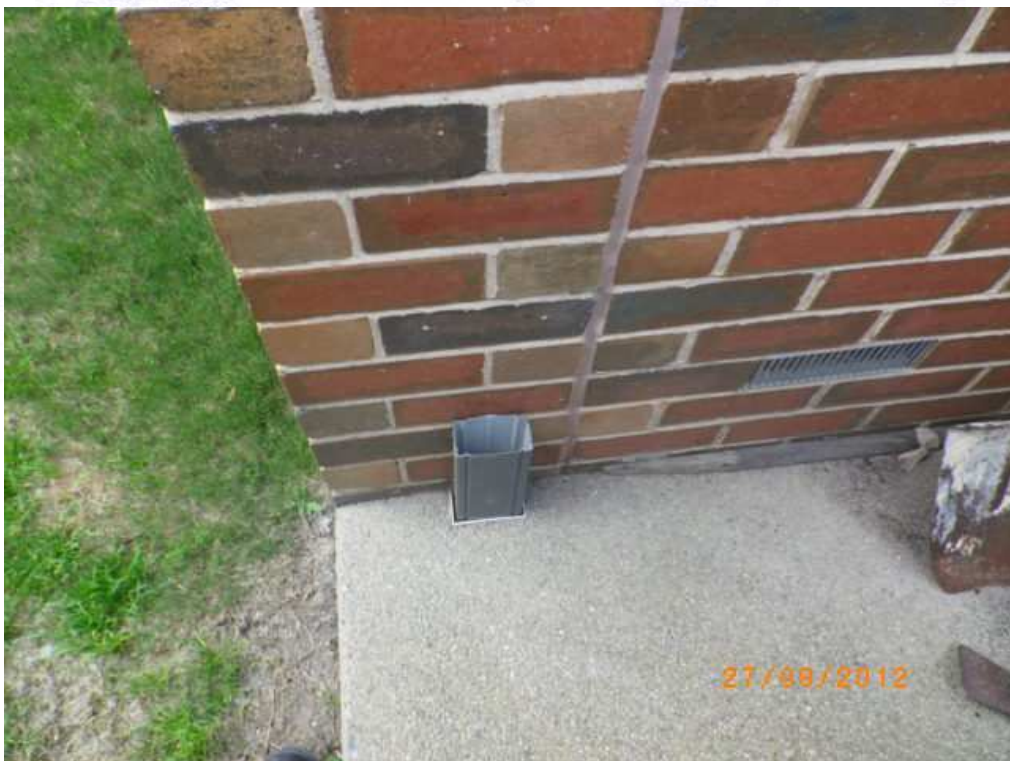
- 5) Downpipe on the north-western corner of the house has been removed to divert water to the water storage tanks. Needs capping

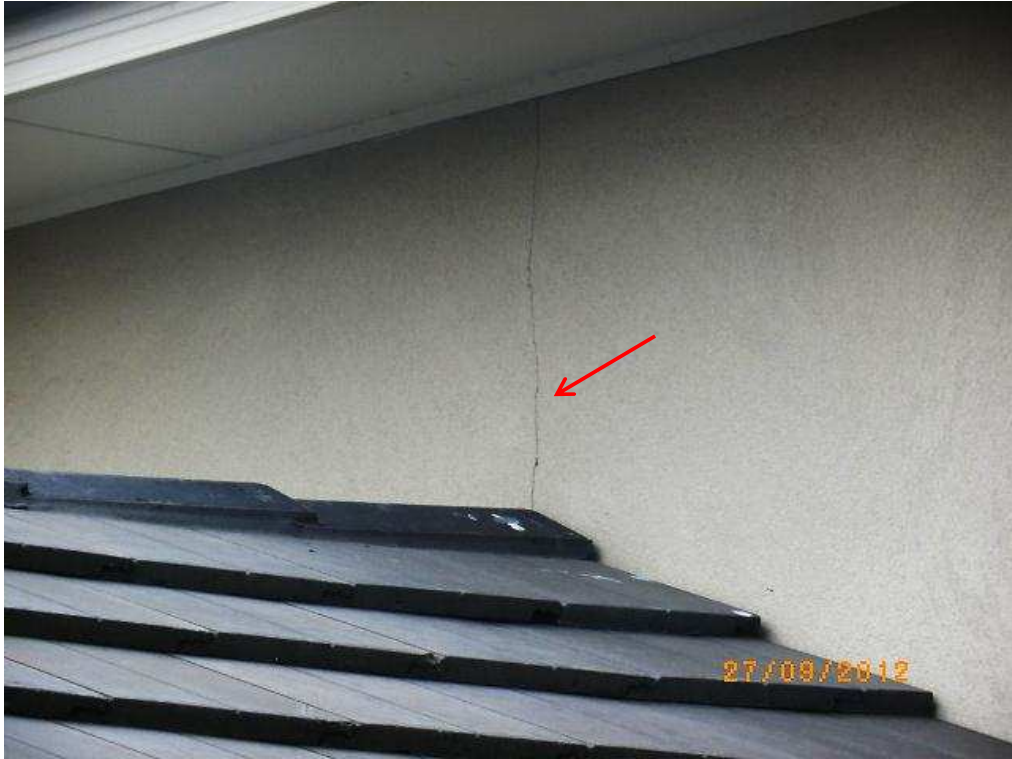
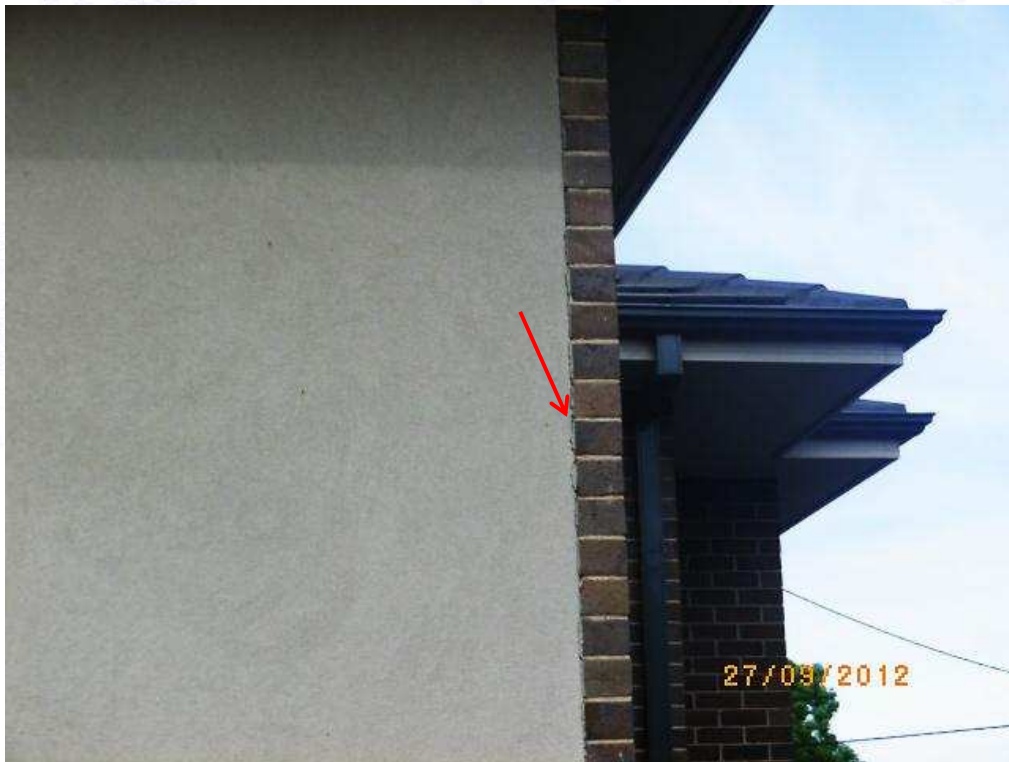
6) Cracking in the cement render on the back wall of the house, above rear roof section

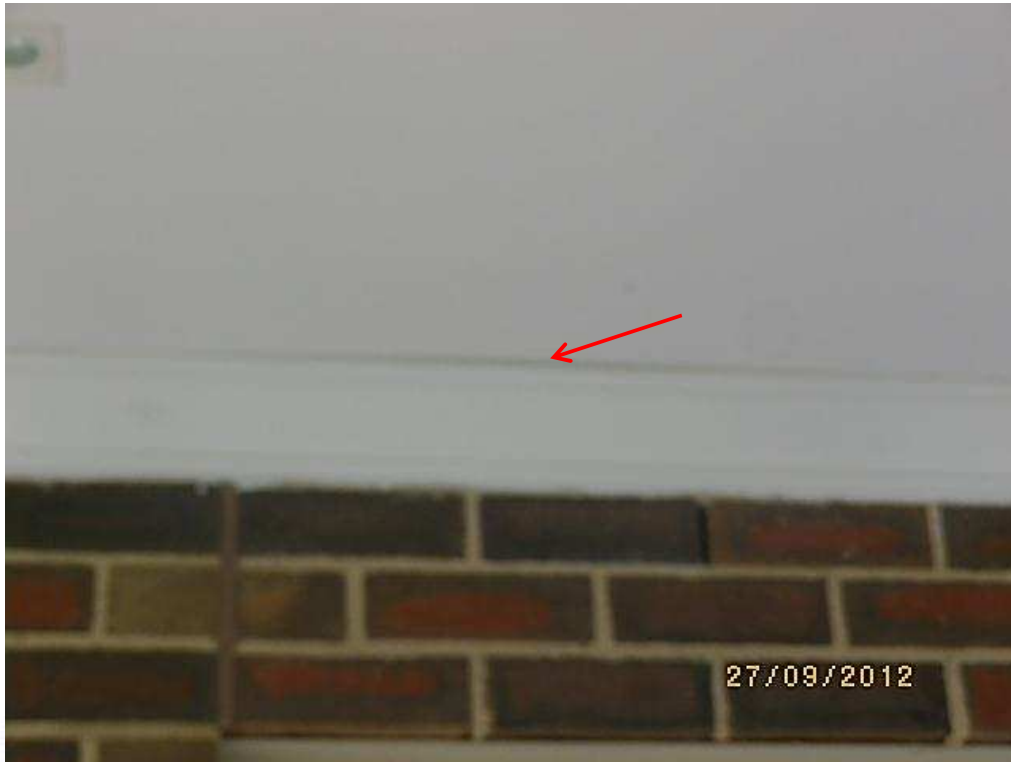
- 7) The cornice under the decking area at the rear of the house is becoming detached in areas

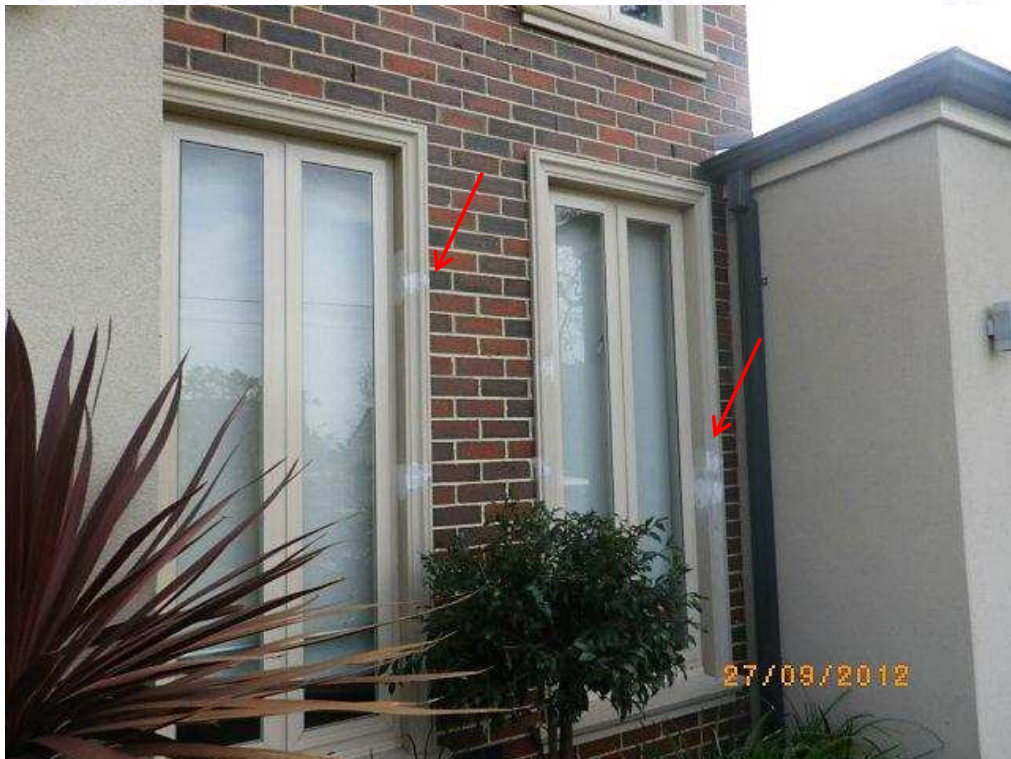
- 8) Unfinished repairs to the external architraves around the front windows

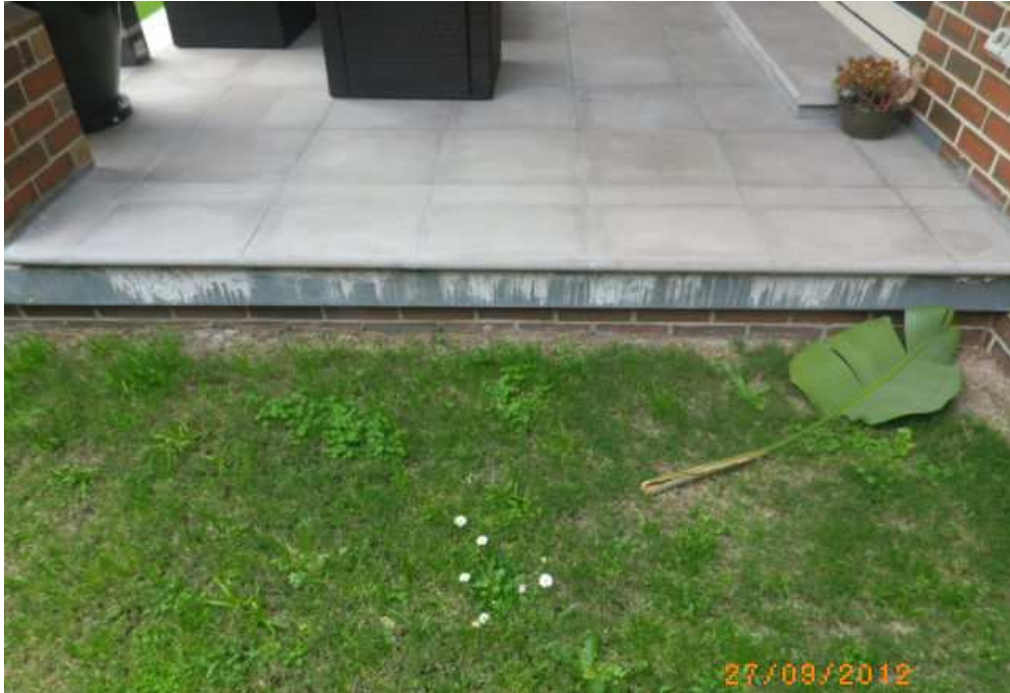
9) Untidy cement marks on the steel beams of the rear decking
